Guidelines for
**Preservation, Stewardship
& Development**

Guidelines for the
Preservation, Stewardship, and Development
of the
Dimock Community Health Center Campus
55 Dimock Street
Roxbury, Massachusetts

Prepared by August Associates, Architects
under contract with
Historic Boston Incorporated
with partial financial support through the
Boston Landmarks Commission
from the City of Boston
Neighborhood Development and Employment Agency
Community Development Block Grant funds.

November 1984

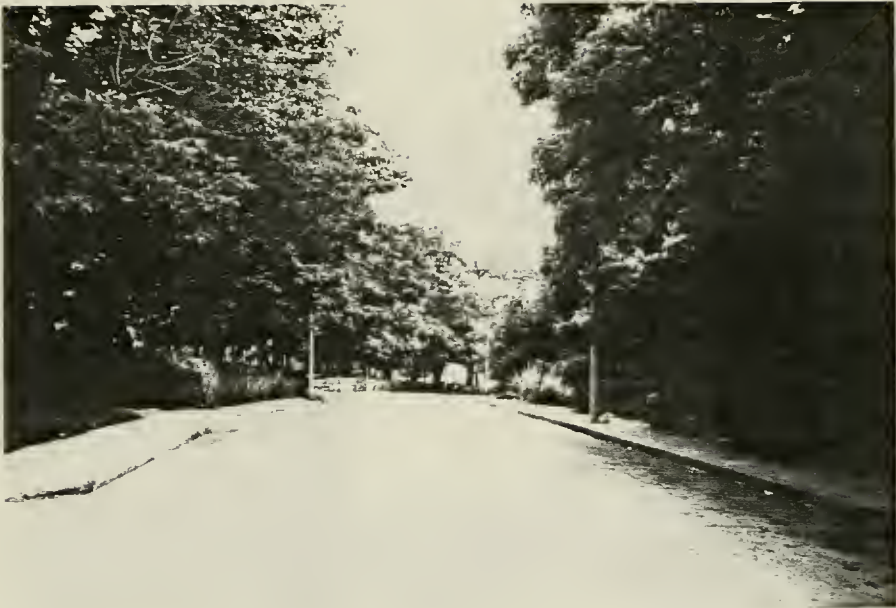
102

The Washington Street entrance needs definition.

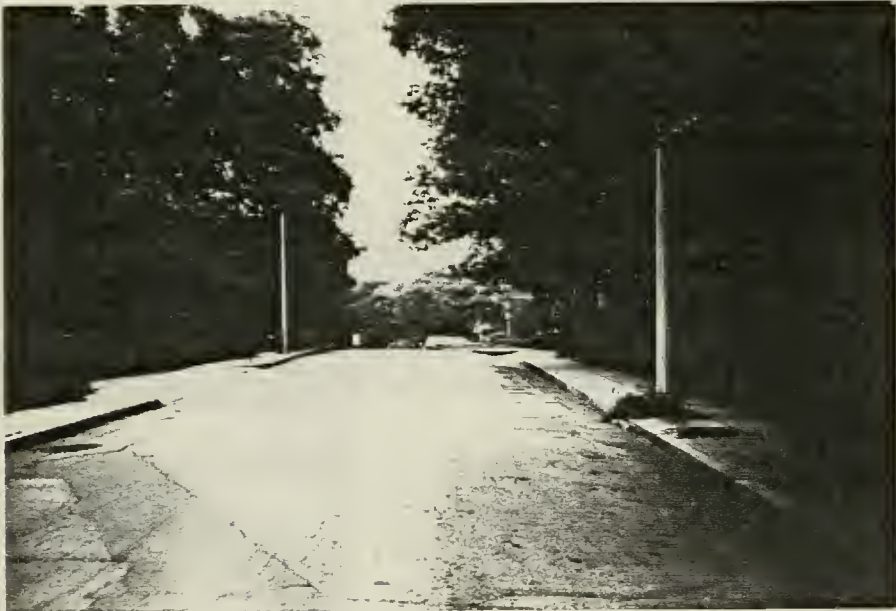
103

There is no indication of arrival or directional information at the Washington Street entrance

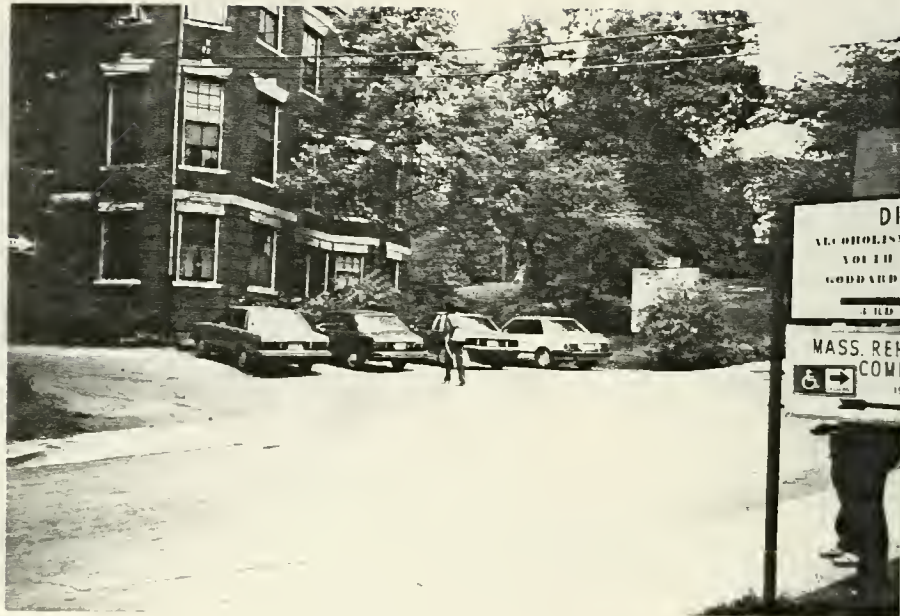
105

The edges of Dimock Street, the campus spine, should be better defined. This can be done through street trees, reduced curb cuts, and restricted parking. The parking shown here should be eliminated.

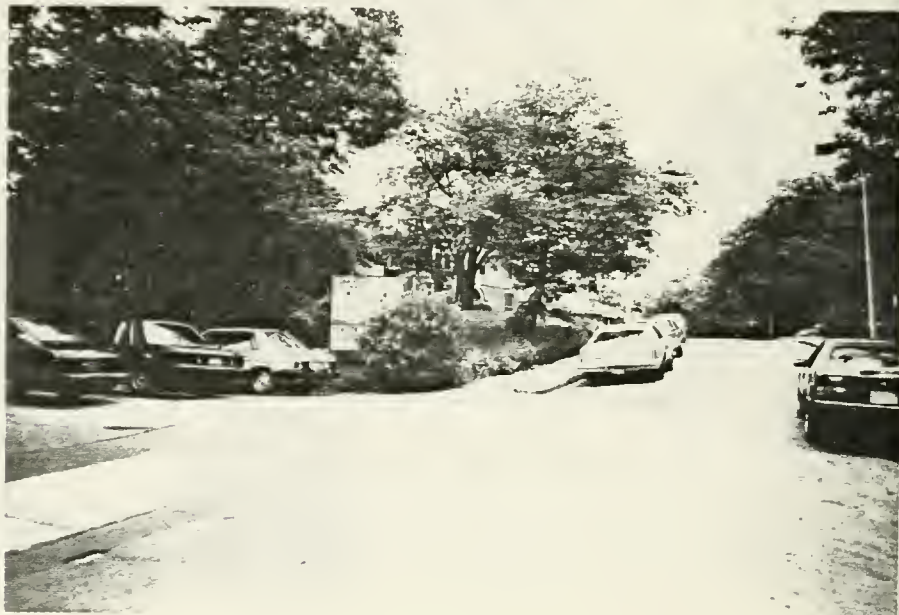
106

Curb cuts along Dimock Street are too broad. Signs too temporary. Site lines obscured by plants. Parking on Dimock Street, if any, should be on one side of the street only.

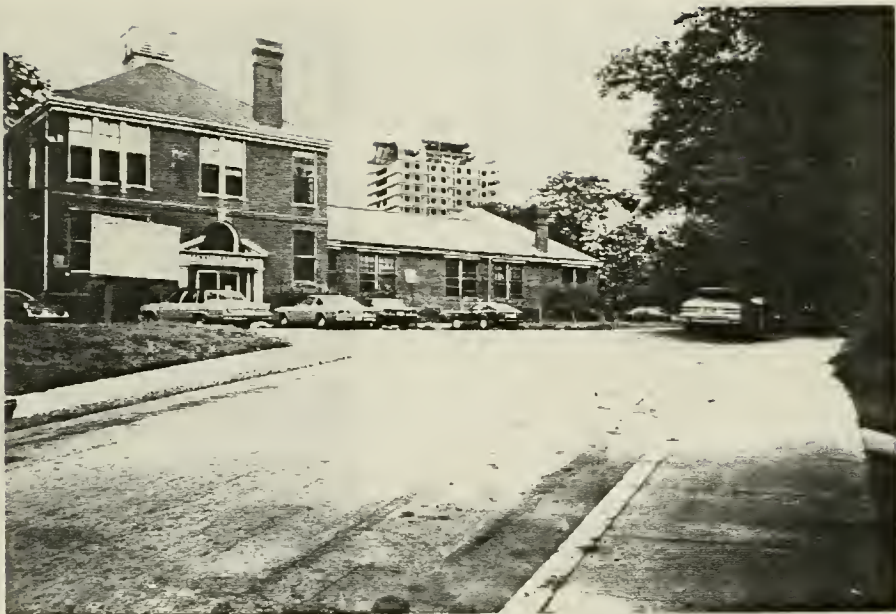
107

Central decision point
without focus or direc-
tional information.
Too much pavement. Too
many cars.

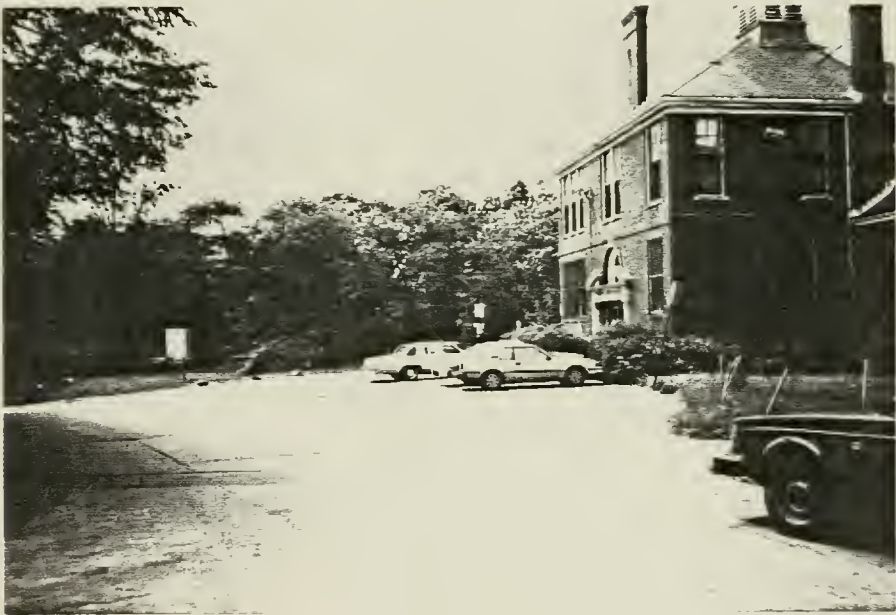
108

The curb cut on Dimock
Street is too broad.
The entrance to the
Sewall building needs
definition.

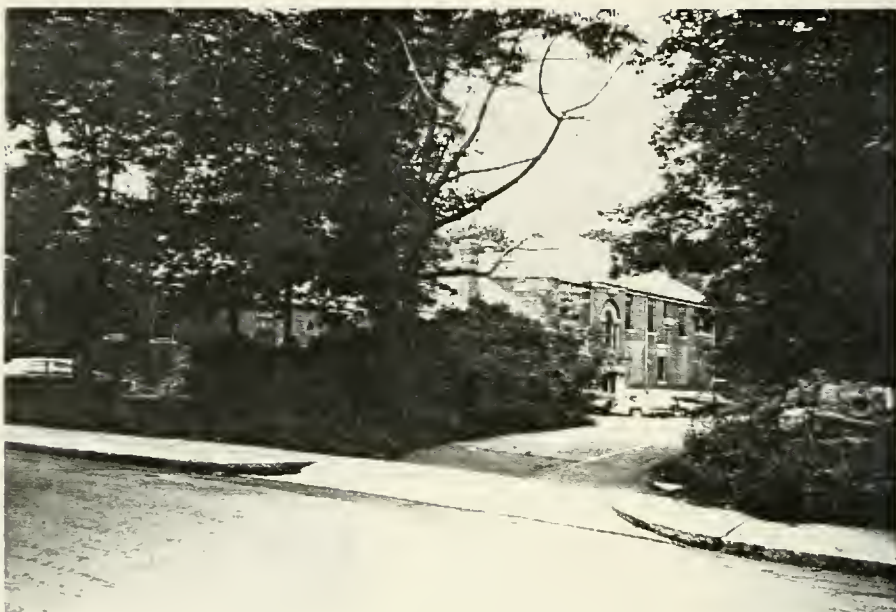
109

The entrance planting gives nice screening for the building but is seasonal. Evergreen materials should be planted and the dead limbs pruned.

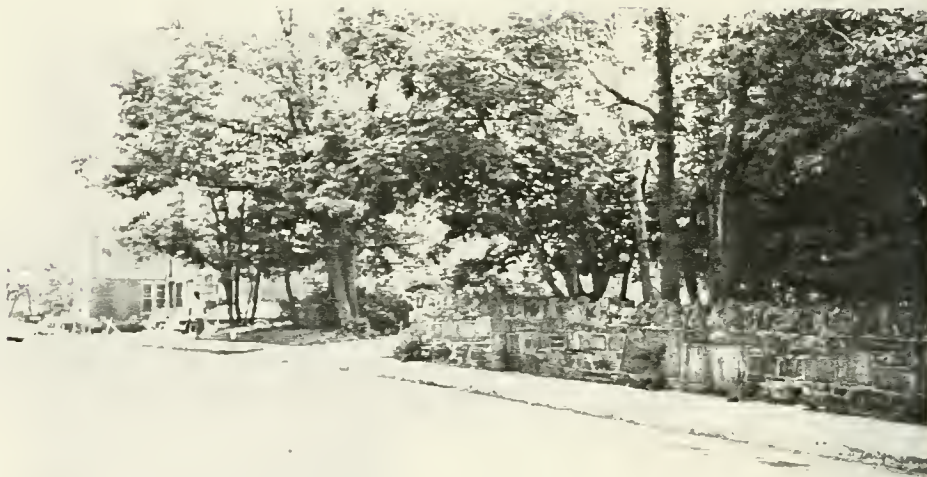
110

This is the entrance to the Dimock Center from Washington Street. There is no indication that one has arrived nor is directional information given.

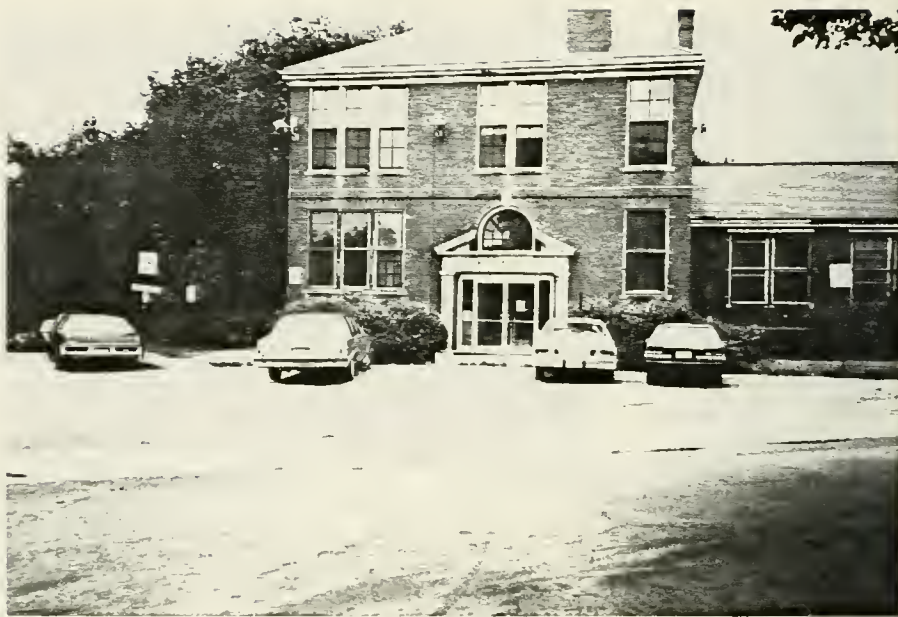
111

The entrance needs to be defined.

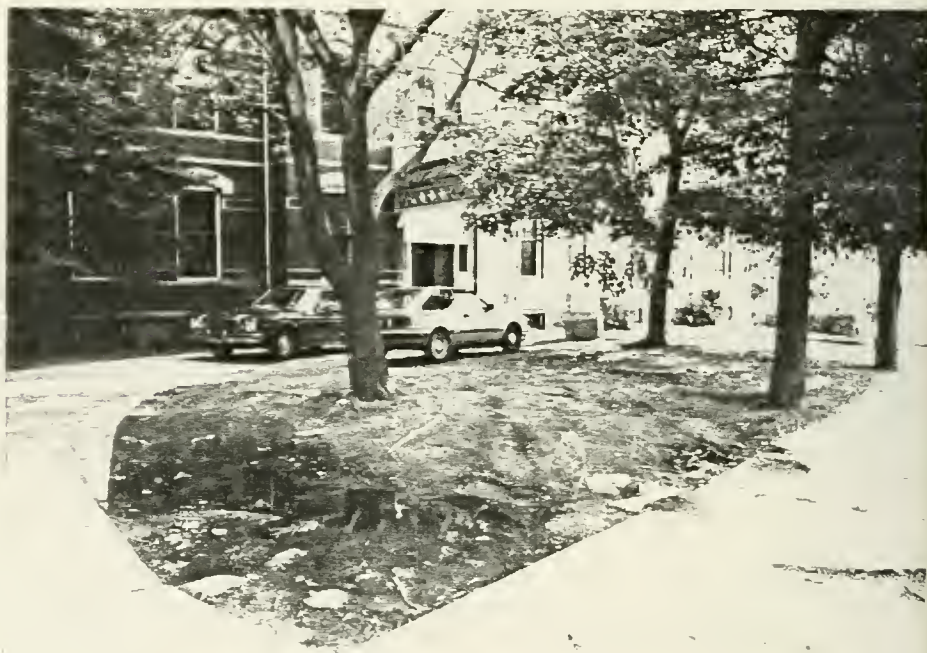
112

This building has a nice entrance which could be greatly improved with proper maintenance and restricted parking.

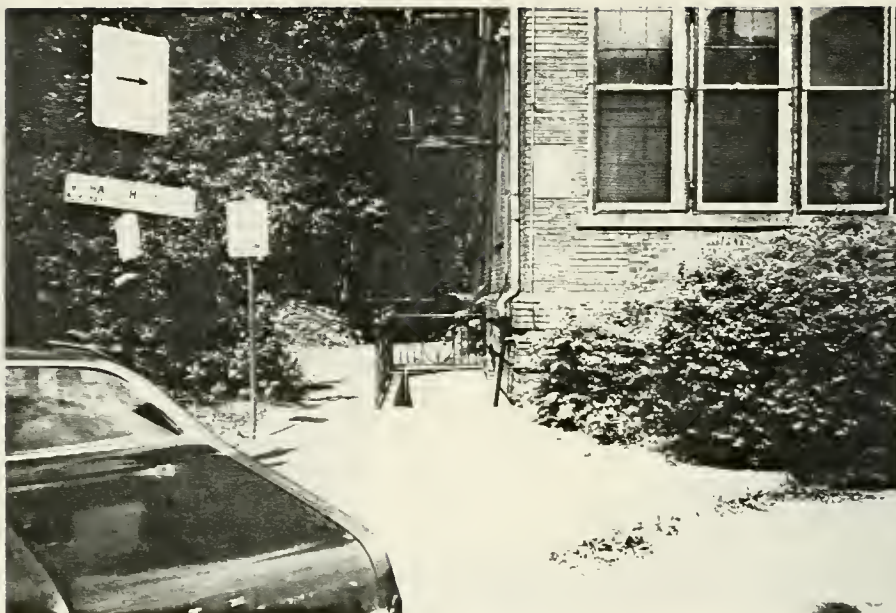
115

The entrance to the Hawthorne Center, passing by the basement entrance, is not well situated.

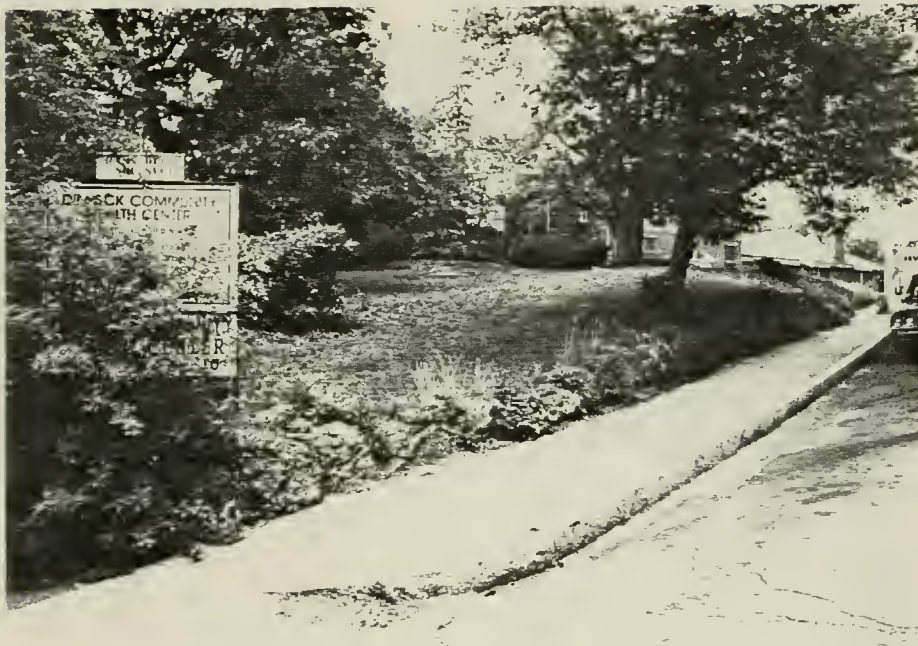
117

Nice view across the campus. Bad sign placement.

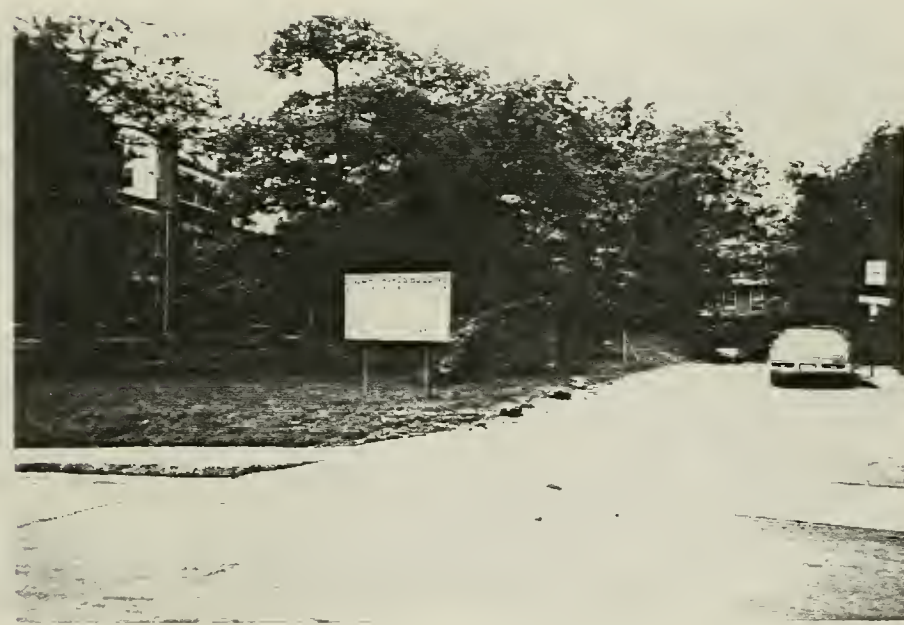
118

Richards sign should be incorporated into the outcrop.

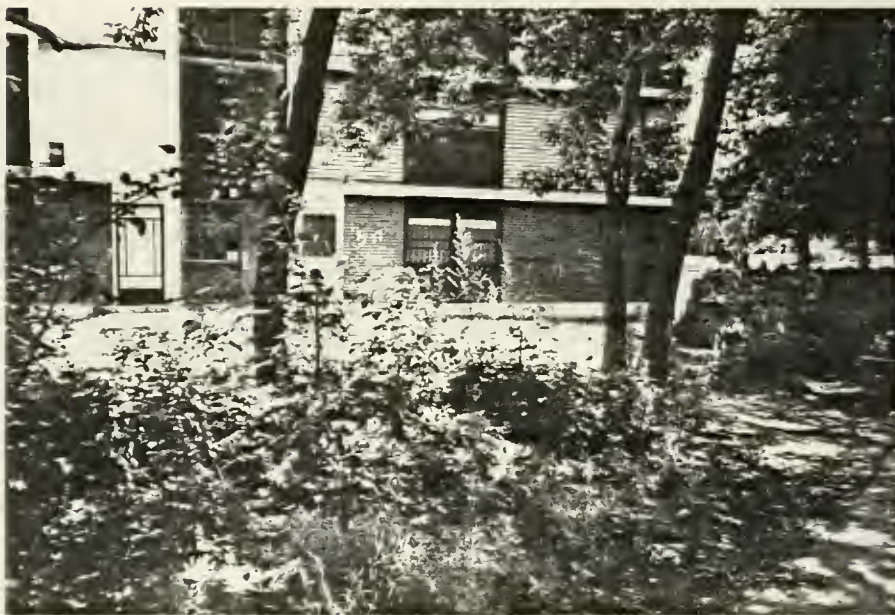
120

The wall needs to be continued to a logical end. If an opening to the apartments is desired, it should be a proper gate.

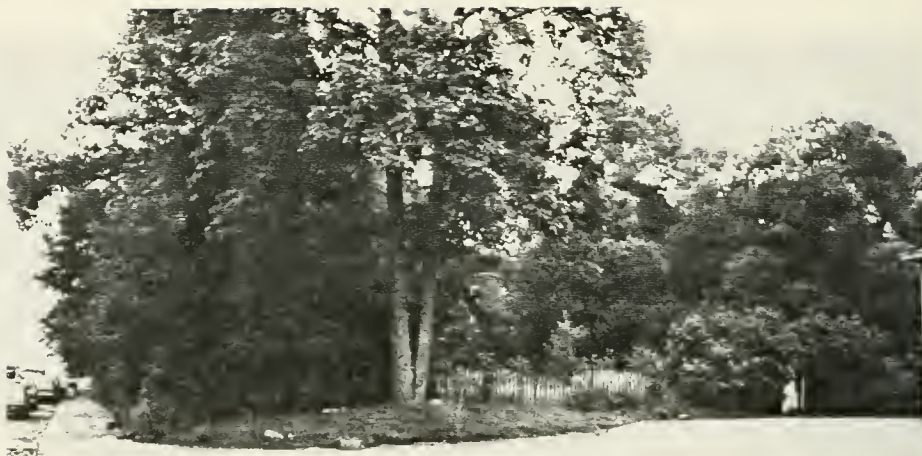
123

Columbus Avenue fence
along south property
line.

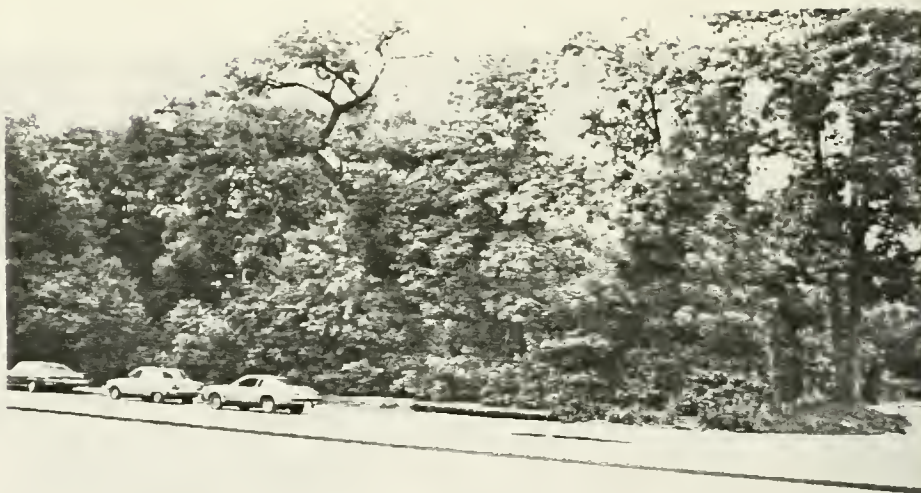
124

Plants growing through
the fence should be
removed.

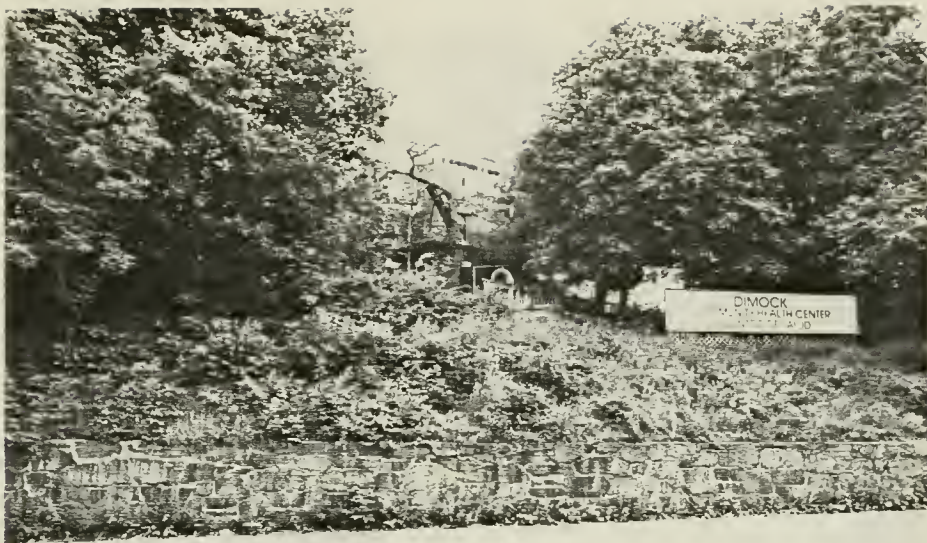
125

The billboard sign should be removed. The stone retaining wall needs tuck-pointing. The view to the Cheney entrance is good.

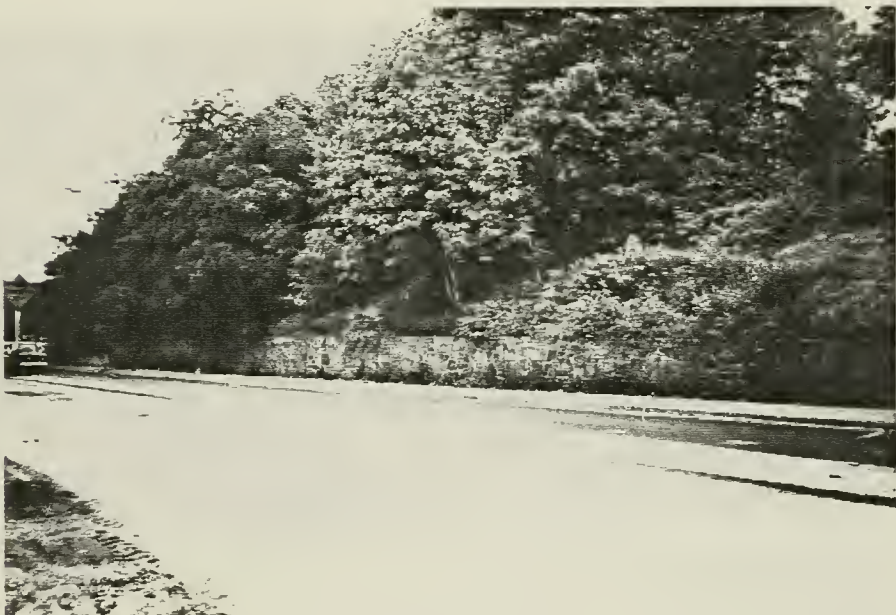
126

The important grade change and dense planting along Columbus Avenue should not be disturbed.

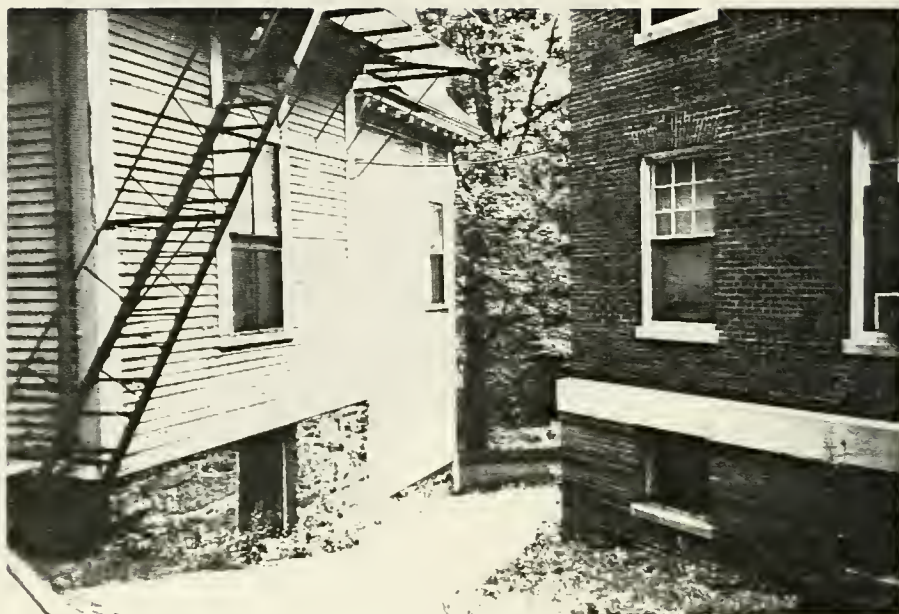
127

Access between the buildings from a lower parking area need to be developed.

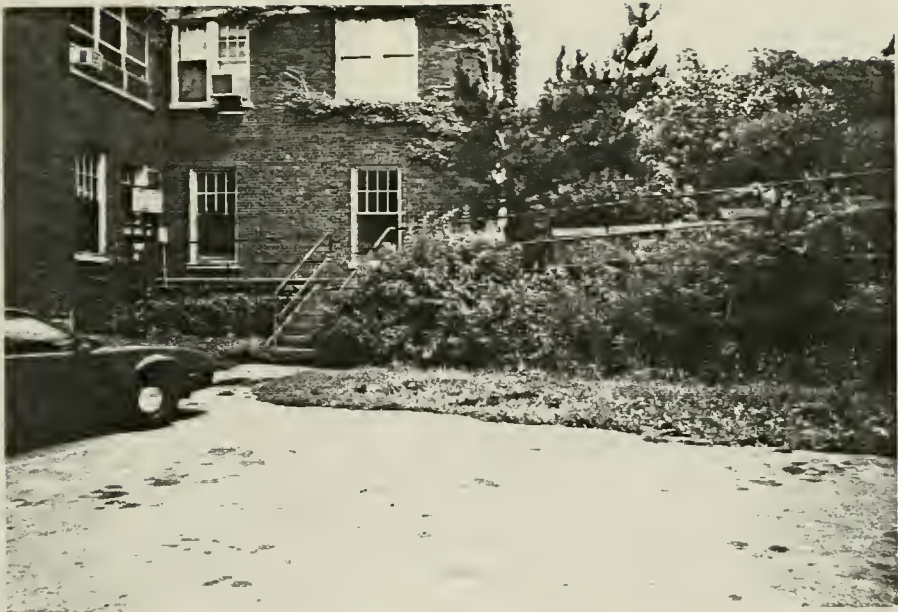
129

The planting of dog-woods, almonds, crabs and/or redbuds along the walkway would soften the parking edge and add interest to the walkway

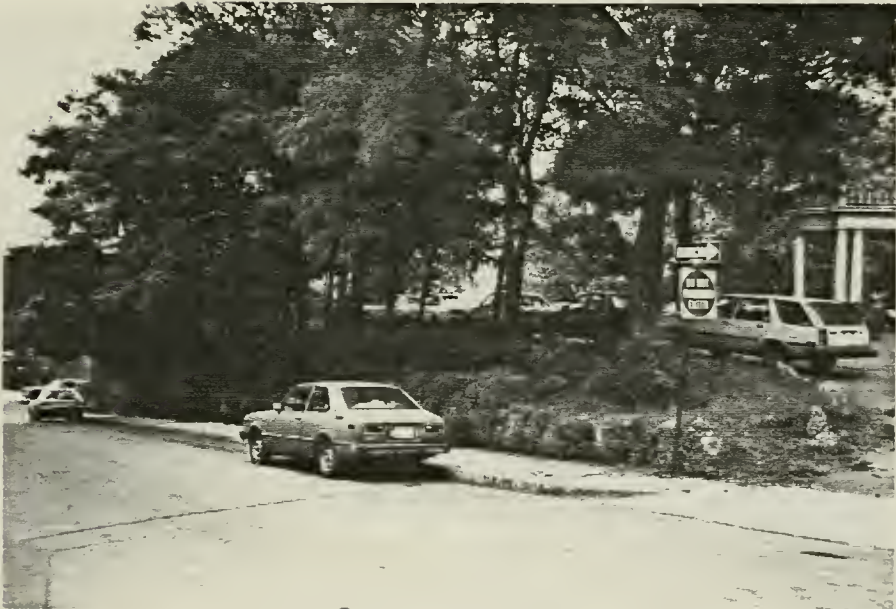
130

Important grade change, additional planting needed to screen cars. Consider arching street trees.

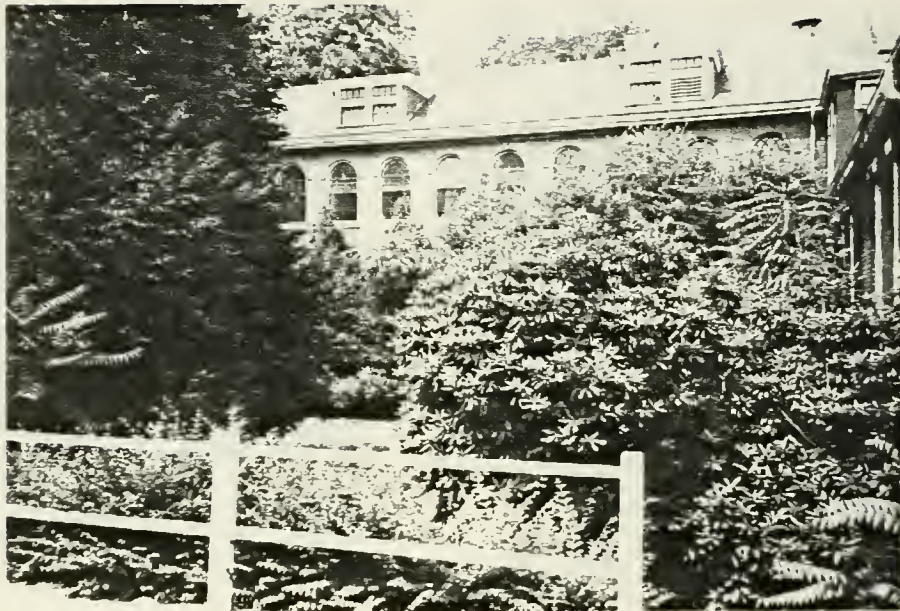
131

The entrance to the Sewall courtyard is obstructed by mature rhododendron.

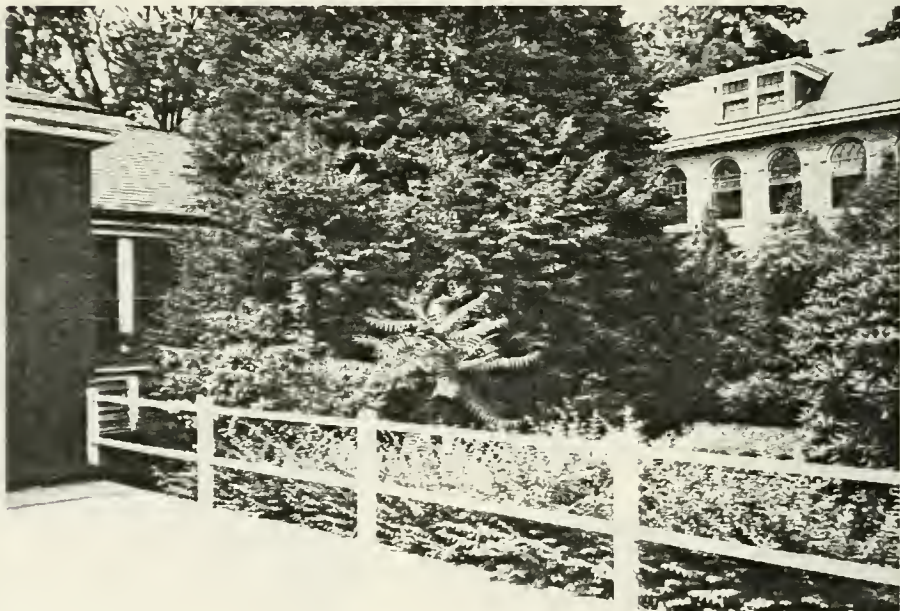
132

The Linden should be pruned to allow benches under the tree.

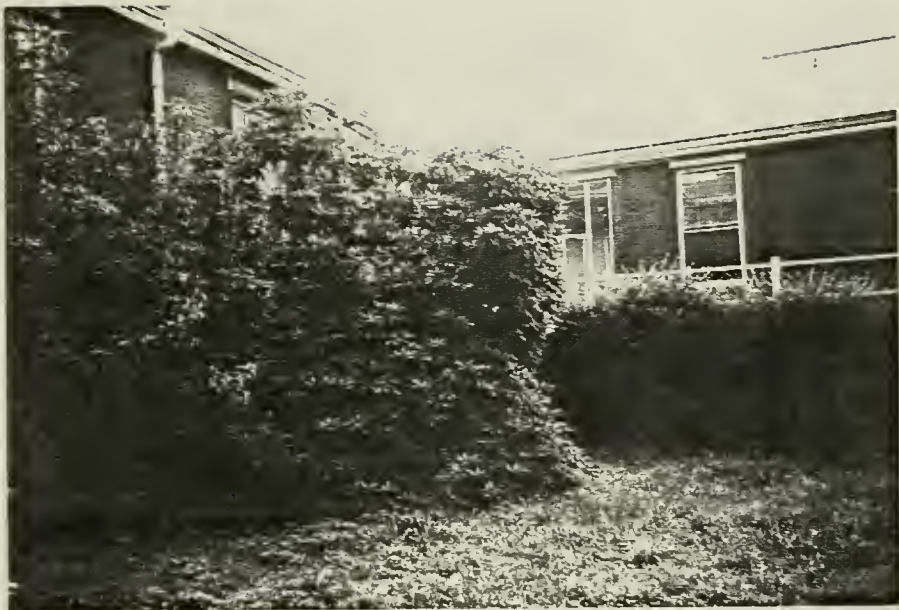
133

Views into the courtyard are blocked by overgrown plants.

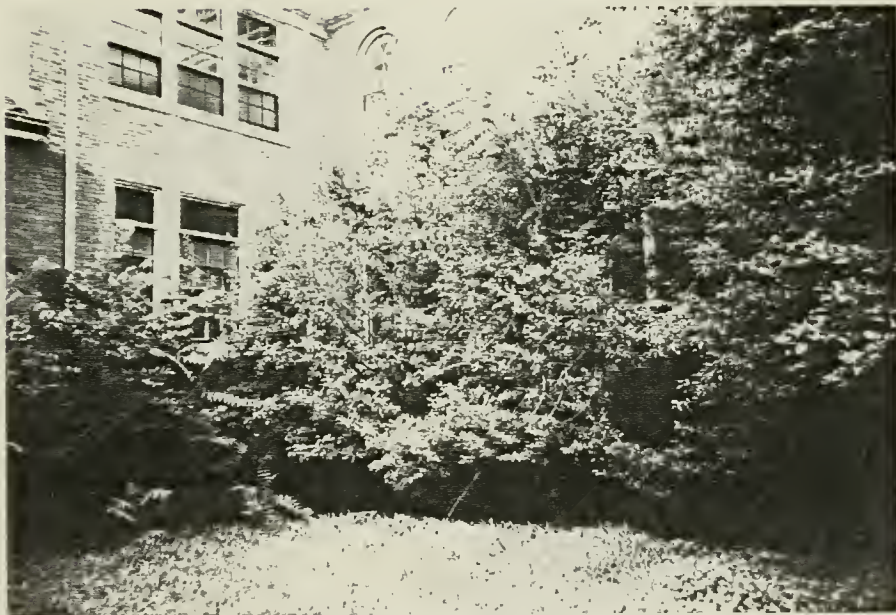
134

Thin crabtrees screening arched windows.

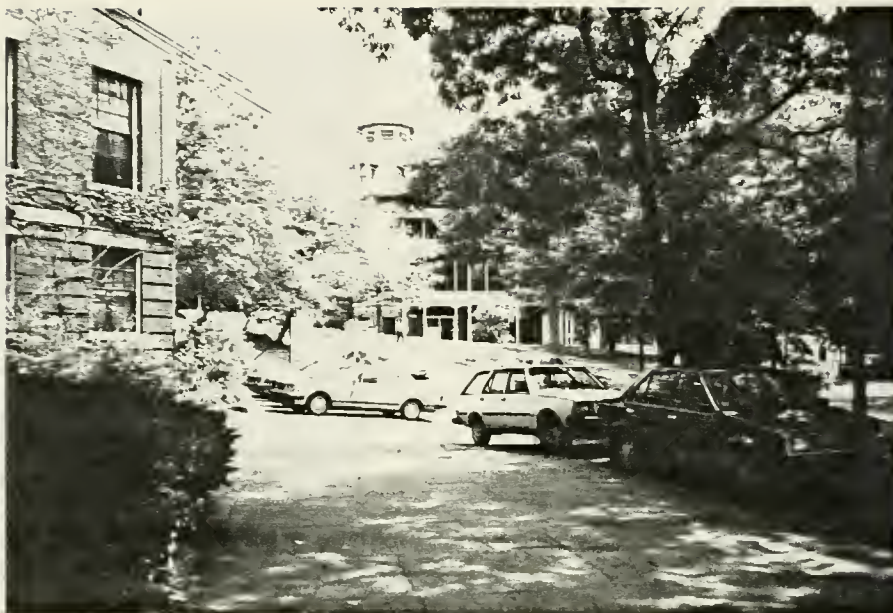
135

Too many cars in the wrong place. This should be the entrance to Cheney.

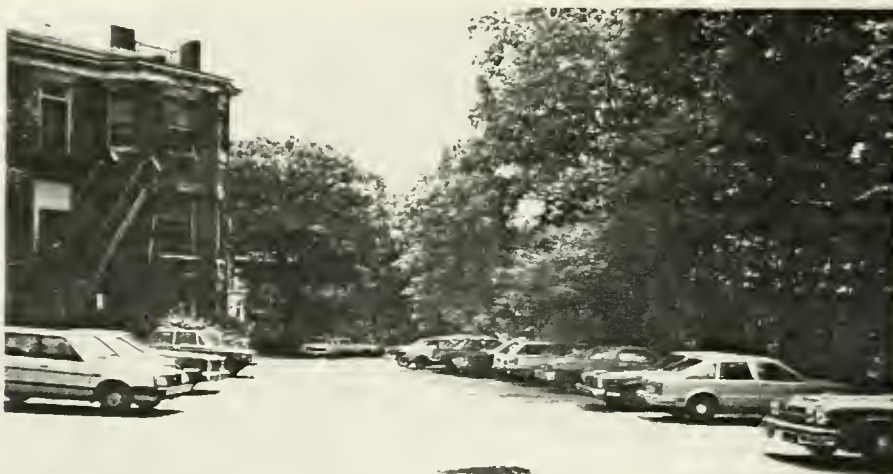
136

Inefficient use of parking lot.

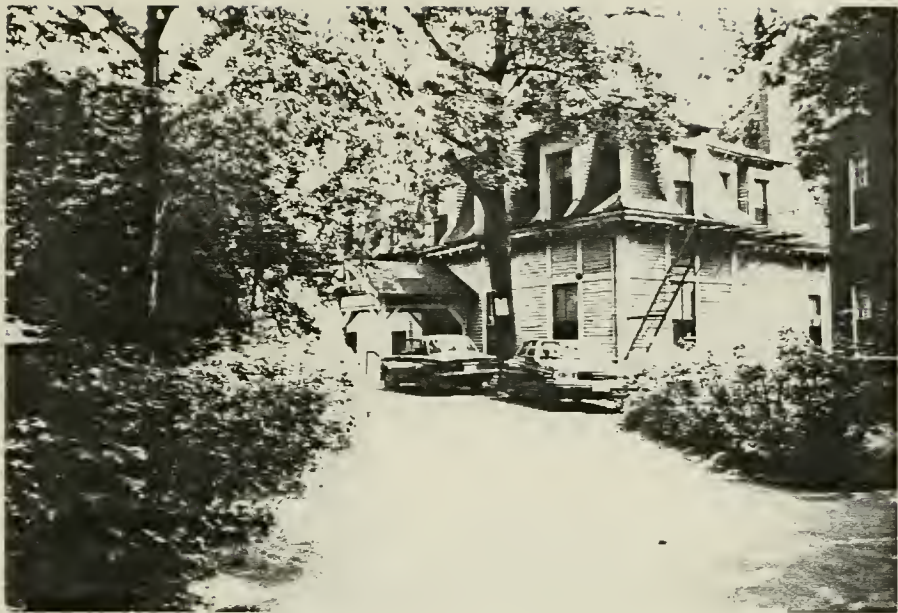
137

Cars parked in the
wrong place.

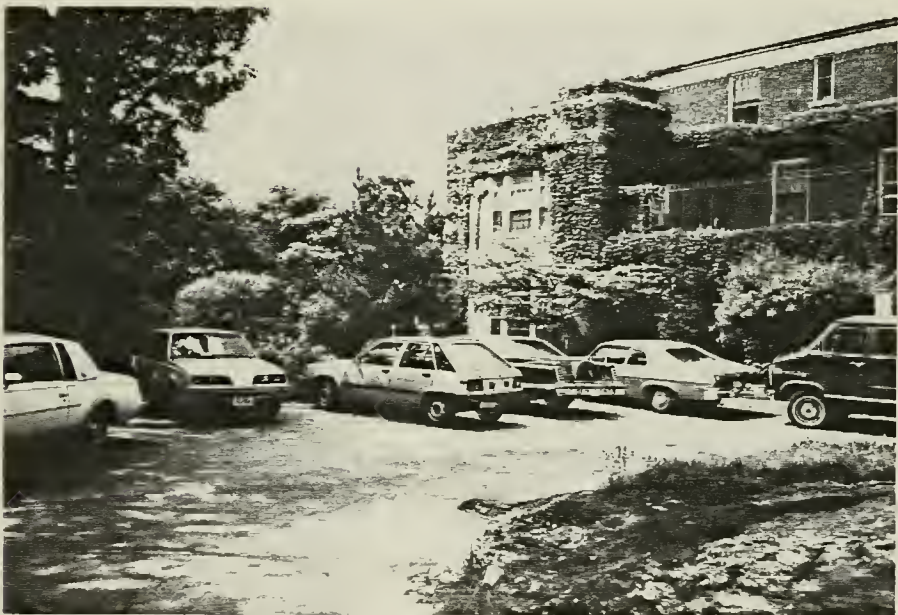
138

Short term parking
could be provided for
here. Present use is
haphazard.

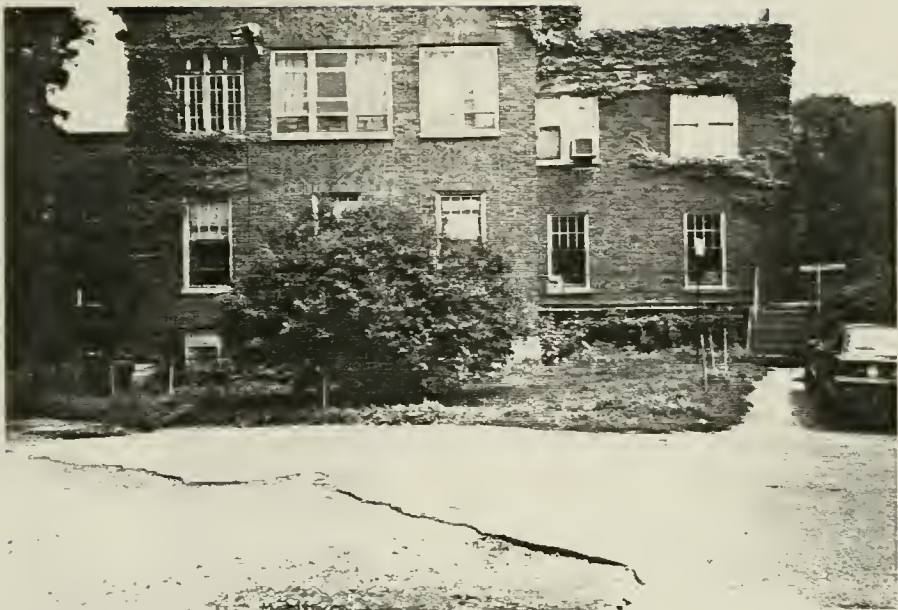
141

Road surfaces, edging, and fencing combine to give an unkempt appearance.

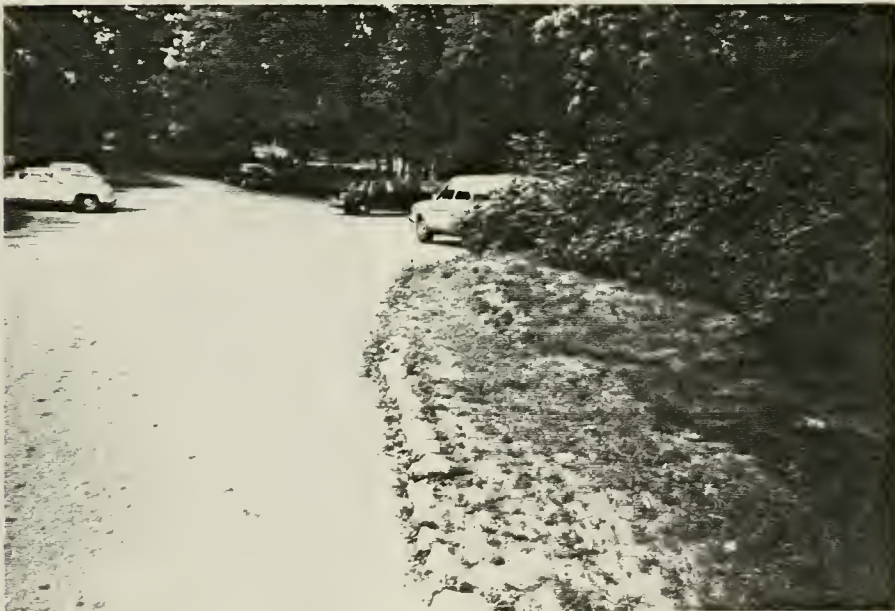
142

Nice materials, cob- bles, needs maintaining to realize potential.

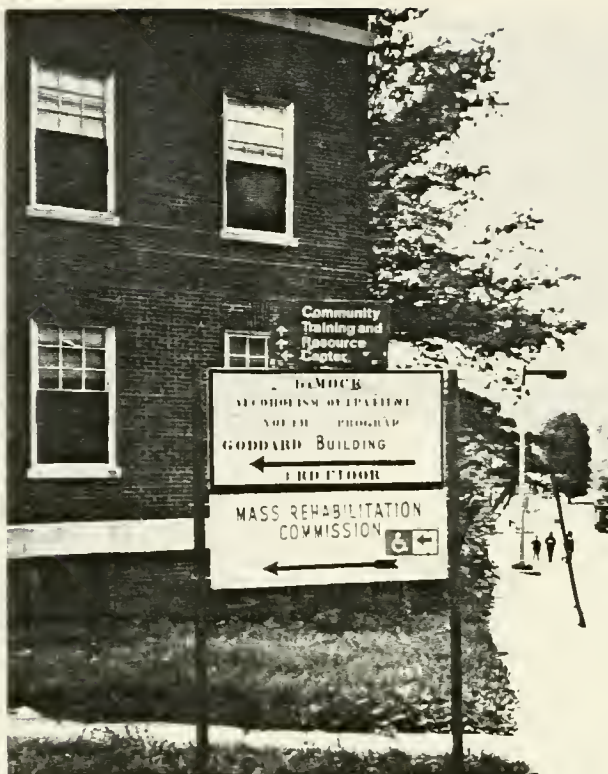
143

Obvious maintenance
needs to be attended
to.

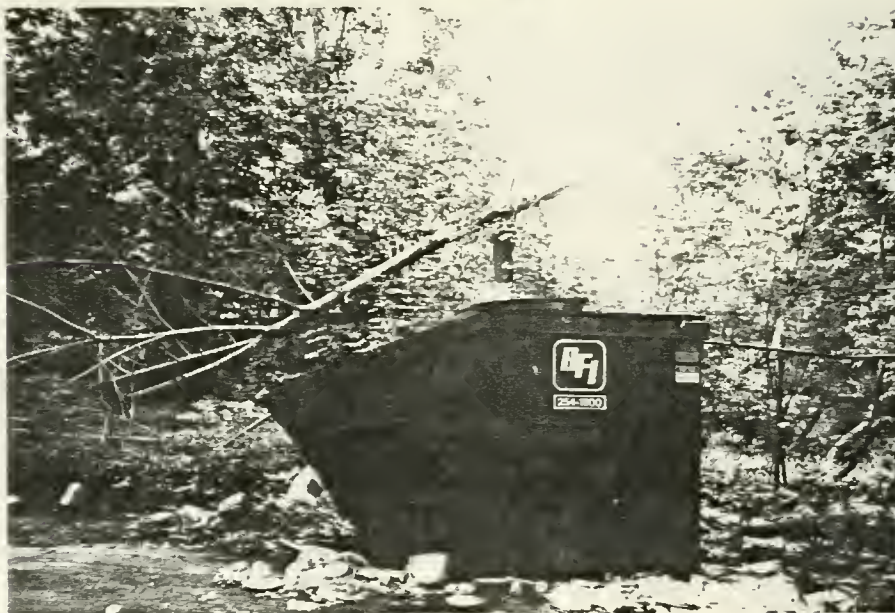
144

Obvious maintenance.
